**DELAWARE RIVER BASIN**

**CLIFF LAKE DAM**

**SULLIVAN COUNTY, NEW YORK**

PHASE 1 INSPECTION REPORT  
NATIONAL DAM SAFETY PROGRAM  
CLIFF LAKE DAM, I.D. NO. NY 584  
DEC #148D-1133  
DELAWARE RIVER BASIN  
SULLIVAN COUNTY, NEW YORK

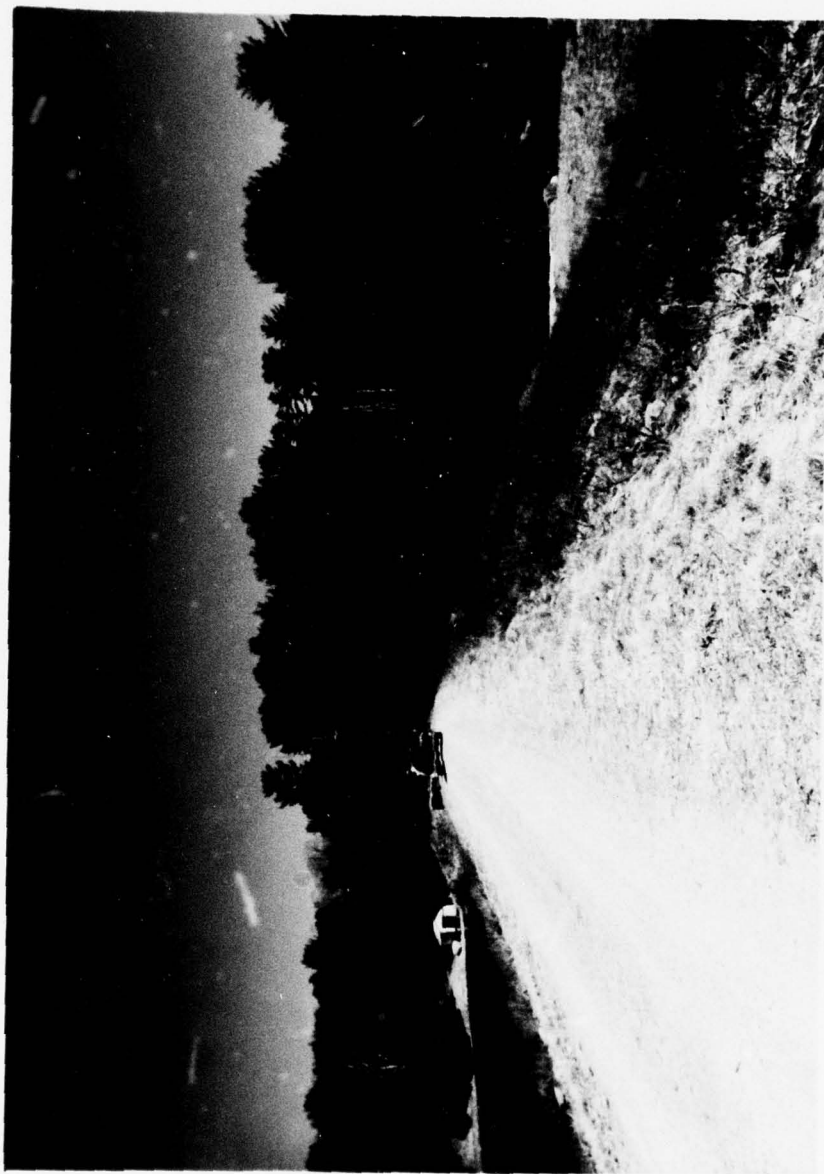
Overview of Cliff Lake Dam  
Photo #1

The horizontal and vertical alignment of the west embankment section appears to be good. No evidence of surface cracks or movement of the slopes, crest, toe, or area beyond the toe was observed. (See Photos #1 & 10) Small trees were evident on the upstream and downstream slopes, and at both abutments. The upstream and downstream slopes are riprapped. A large depression was observed in the original grade beyond the west abutment, the origin of which is unknown. Trees growing in the depression indicate that this depression is not of recent origin. (See Photo #13) No erosion at the abutments was apparent.

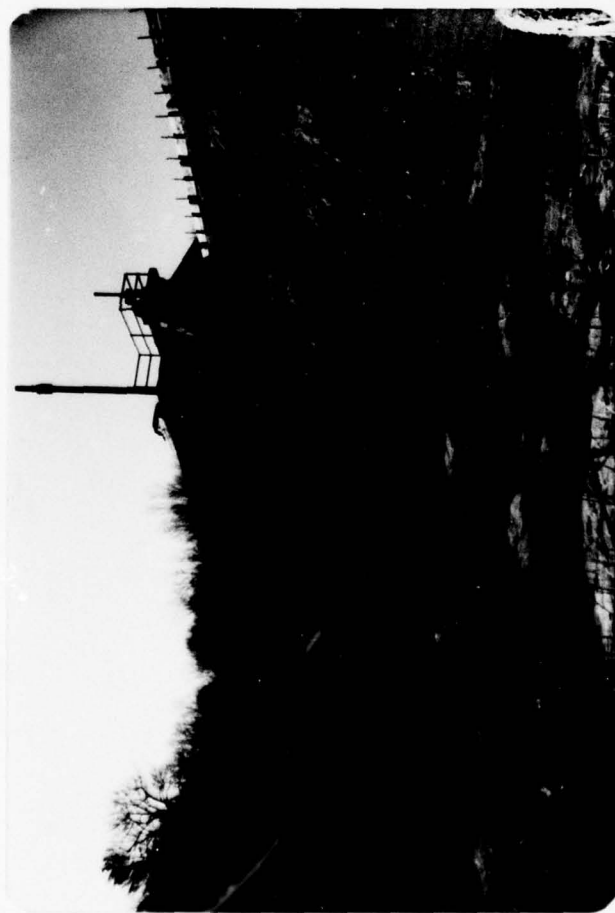
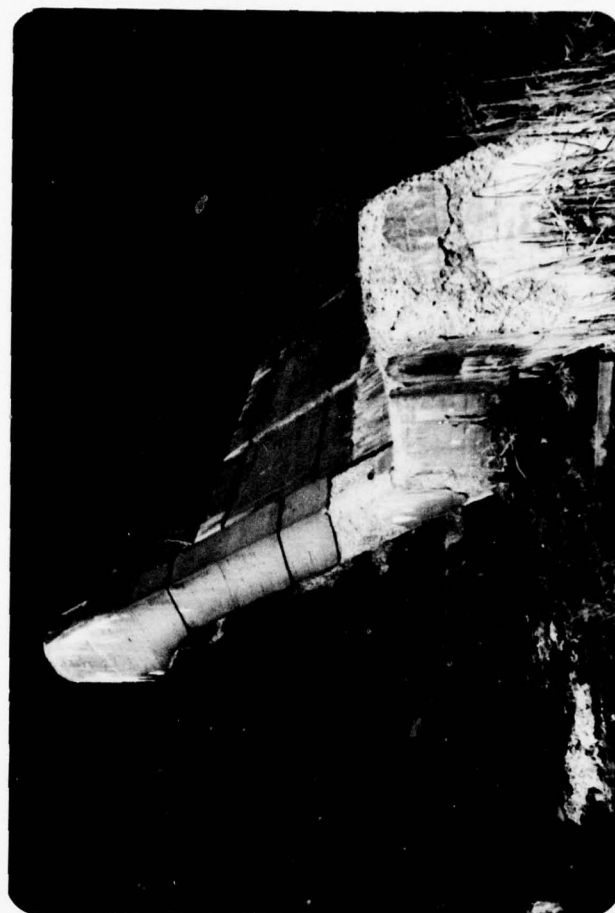
Surface spalling of concrete was evident particularly at the construction joints. The wingwalls are cracked and deteriorated. Hairline cracks were noted in the spillway concrete. A 1-inch opening was observed at the contact of the spillway toe and the apron. No indication of recent movement and no seepage was observed. (See Photo #3) A 2-inch diameter pipe was protruding from the spillway; purpose unknown. Two rectangular drains were noted at the base of the spillway. (See Photo #4) These drains provide relief of seepage and uplift forces beneath the spillway and non-overflow sections (See sketch Appendix C, Section 6, and Appendix G, Drawings #1300-56 and 1300-57 for drain details). Seepage from these drains was clear and estimated to be 5 gpm from the west drain and 8 to 10 gpm from the east drain. Approximately 1 gpm was evident seeping from the east wingwall drain. These drains are partially blocked with debris and vegetation. The area behind this wingwall is soft and wet with vegetation present having an affinity for water (See Photo #3B).

Spillway  
Note Deteriorated Concrete  
Photo #3 A&B

1. Significant deterioration of concrete particularly at the construction joints require repair.

- a. Results of the required investigations will determine the type and extent of remedial measures necessary.
- b. Repair cracked, spalled, and deteriorated concrete portions of the spillway section, non-overflow section, reservoir drain, and its cover slab. Repair all construction and expansion joints.
- c. Clean and monitor all foundation drains at the base of the spillway and non-overflow sections.
- d. Remove tree, vegetative growth and debris from the crest, slopes, abutments, toe, spillway channel, outlet channel, and downstream channel above the access road bridge.

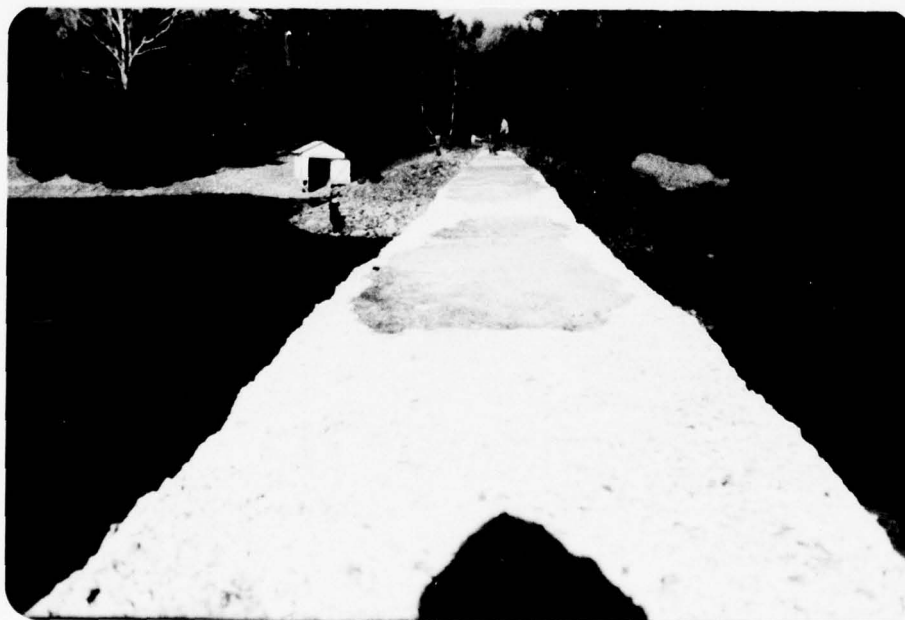
Surface spalling, calcification, and deterioration was evident in the non-overflow section of the dam particularly at the construction joints, along the top of this section and at the east wingwall of the spillway (See Photos #5, 6, & 7). Surface spalling on the eastern most panel of the downstream face was 2 to 3 inches (Photo #7); on the upstream face spalling was approximately 6 inches at the western most construction joint. Numerous hairline cracks were evident, and 2 of the vertical shear keys at the construction joints had hairline cracks through the shear key, indicating reduced strength of the key. A large depression at the base of the non-overflow section was observed (See Photo #7). The size of the depression was 28 feet long, 5 feet wide, and 3 feet deep. The origin of the depression is unknown. No evidence of seepage or erosive

The horizontal and vertical alignment of the east embankment section appears to be good. No evidence of surface cracks or movement of the slopes, crest, toe, or area beyond the toe was noted (See Photo #5). Small trees were evident on the upstream and downstream slopes, at the east abutment, and on the crest of the embankment. The upstream and downstream slopes are riprapped. No evidence of seepage was encountered on the slopes, at the toe or abutments, or beyond the toe of the east embankment section.

Crest of Non-overflow Section and East Embankment  
Photo #5

1. Significant deterioration of concrete of the non-overflow section should be repaired.
2. Investigate the condition of the shear keys to determine if the necessary strength is available to resist the shear forces.
3. Investigate the area at the toe of this section to determine the condition of the foundation drain outlets and the large depression. Drains should be kept free of debris and an outlet of sufficient capacity installed and maintained to assess the conditions of seepage and uplift beneath the dam.
4. Seepage observed exiting from behind the east spillway abutment should be investigated. This may be related to the adjacent foundation drain system.

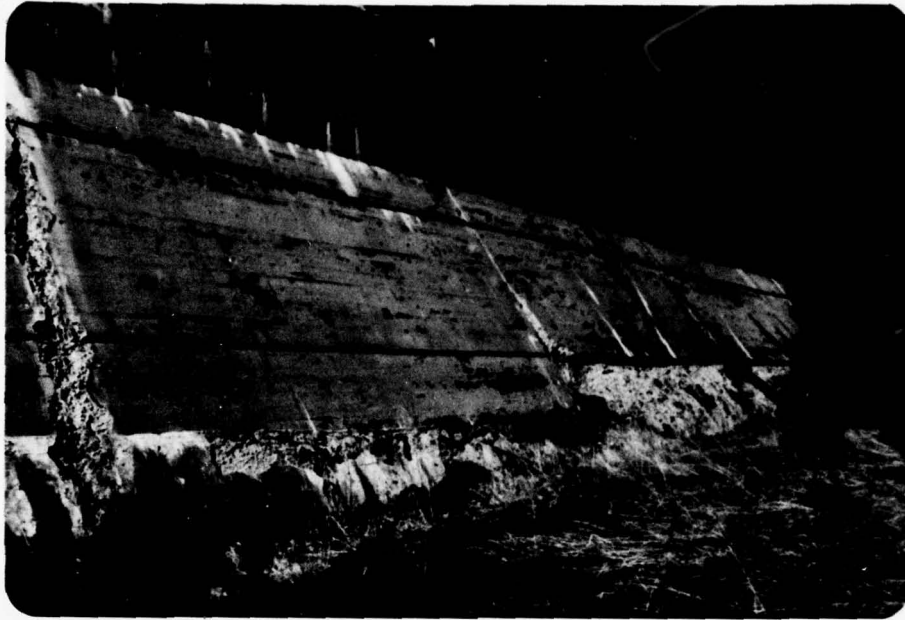
Non-overflow Section  
Downstream Face  
Photo #6

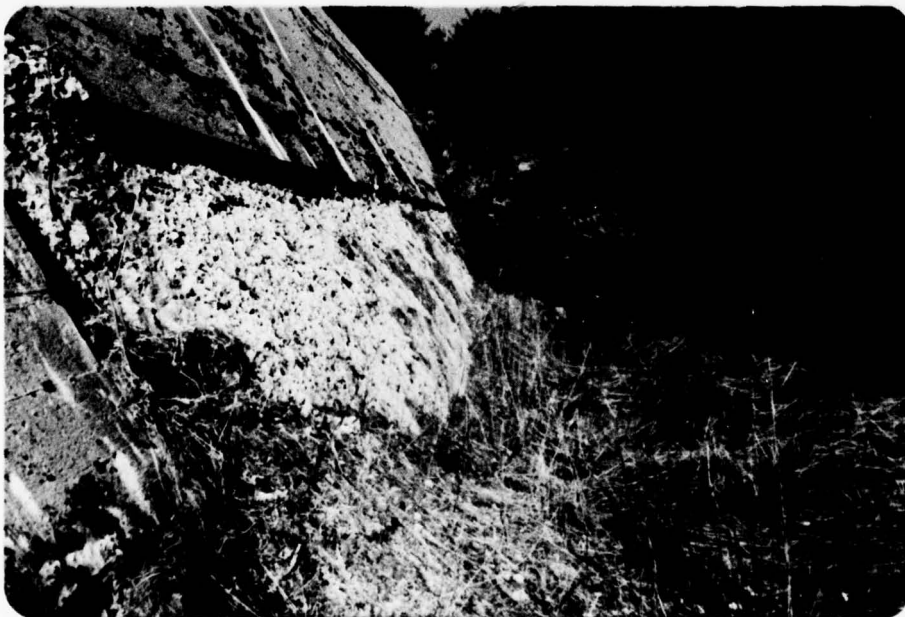
force was apparent, which would be needed to create this depression. This area may have been the remnants of construction excavation, or post construction excavation to clear the foundation drain outlets.

The plans indicate that 3 foundation drain outlets were installed at the toe of this section. Apparently, backfill at the toe obscured these outlets. Seepage encountered in the backfill of the east spillway abutment may result from these outlets.

Deteriorated Panel Non-overflow Section  
Note Depression at Toe  
Photo #7

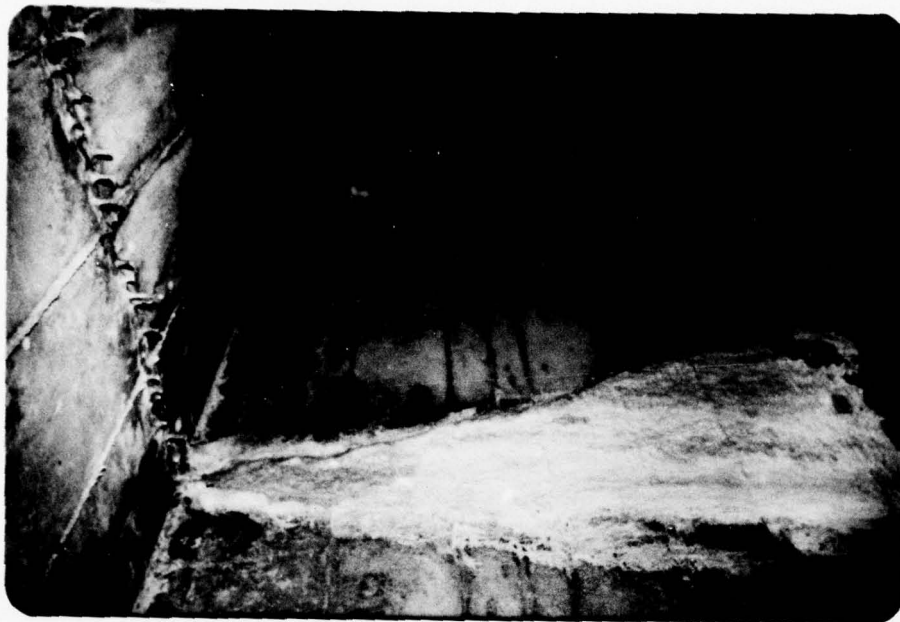
The concrete at the drain is deteriorated at the outlet with reinforcing bars exposed. Slight seepage and calcification was evident in the walls of the drain initiating from the joint between the top and walls of the box drain. (See Photos #8 & 9) the concrete slab at the west end of the spillway channel which covers the reservoir drain is deteriorated and some reinforcing is exposed. Surface spalling was noted particularly at the construction joints.

Reservoir Drain Interior  
Note Calcification at  
Construction Joint  
Photo #9

1. Repair the deteriorated concrete of the reservoir drain. Repair the construction joints within the drain.

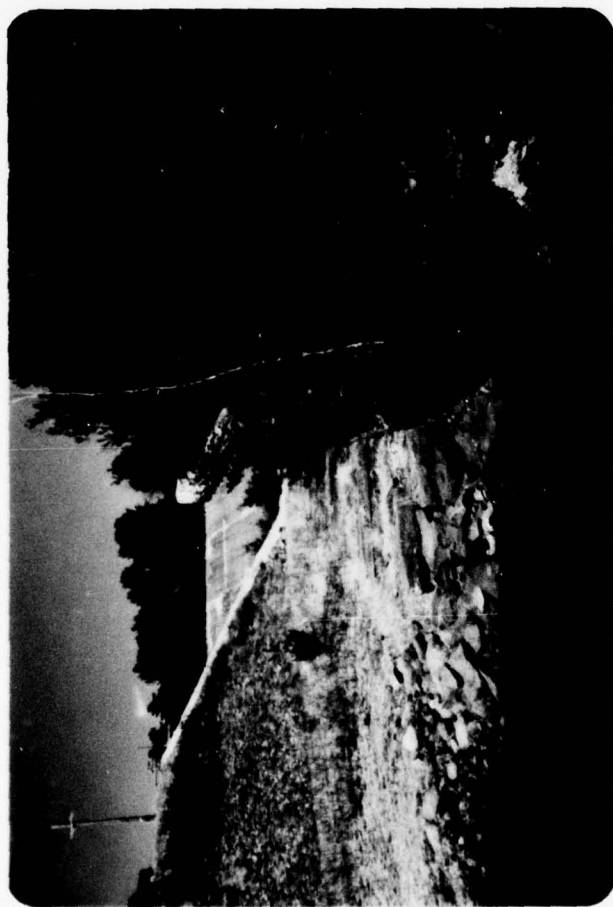
West Embankment and Spillway  
Note Crest of Abandoned Masonry Dam  
Photo #10

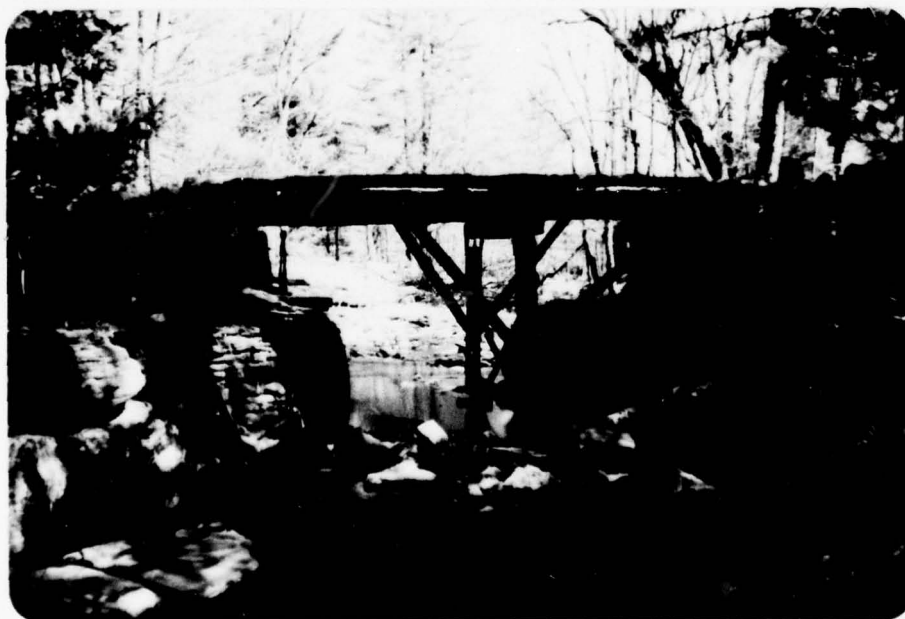
Considerable tree growth and debris was observed in the outlet channel and spillway channel. An access bridge also constricts the spillway flow below the dam. (See Photo #15) The outlet channel is extremely narrow and overtopping of the channel walls may result during high flow conditions.

The downstream channel is partially bedrock formed. Numerous small trees, debris, and rock outcrops were observed. The side slopes appear to be stable with no unusual erosion problems observed. A narrow access bridge crosses the downstream channel approximately 50 feet below the old masonry dam. A sketch of this bridge is included in Appendix C. The bridge is used solely for maintenance and operation purposes by Orange and Rockland Utilities. (See Photos #14, 15 & 16)

Downstream Bridge and Channel  
Below Abandoned Masonry Dam  
Photo #15

Remove all trees and debris found within the downstream channel immediately above the access bridge to maintain a clear channel between the dam and the bridge.

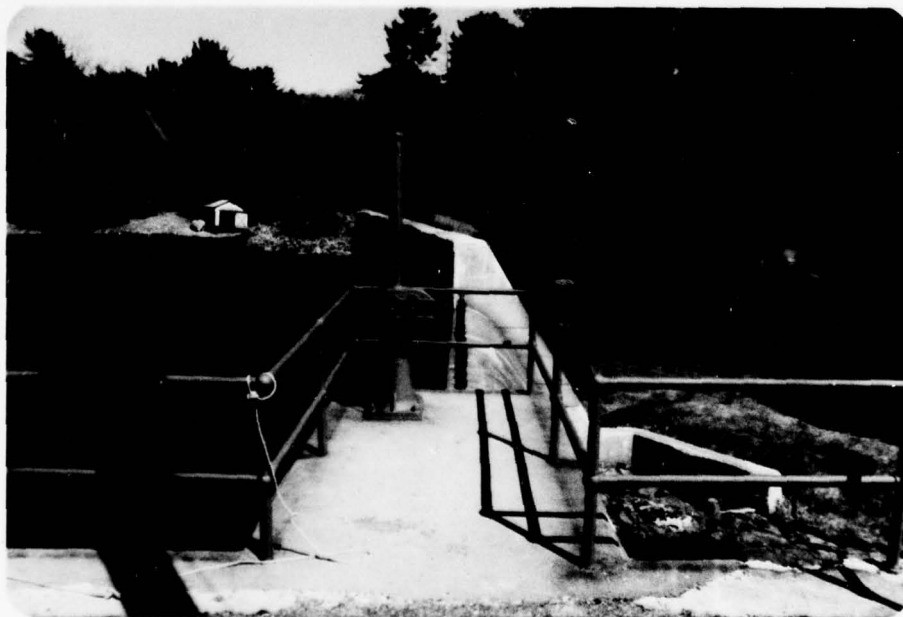
Reservoir Drain Controls,  
Crest of Spillway and Non-Overflow Section  
Photo #17

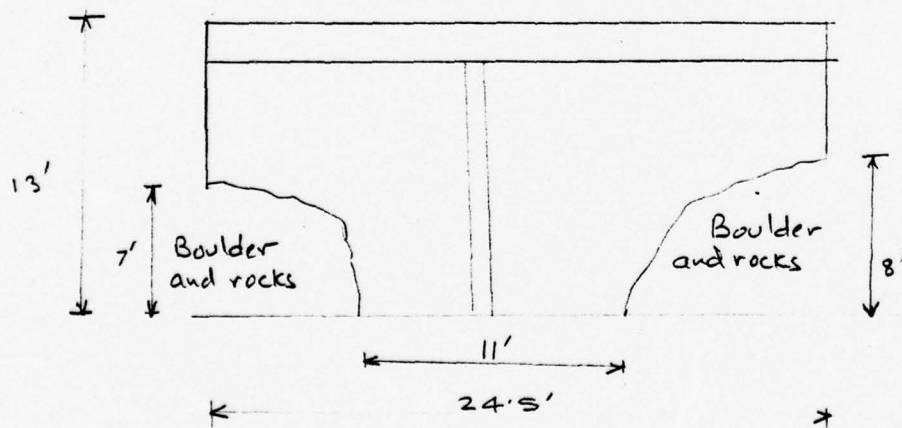
Access bridge on downstream channel  
Looking downstream.
